TO: File

FROM: Chris Oliver, Myakka Wild and Scenic River Biologist
District 4 Administration

SUBJECT: Myakka Wild and Scenic River (MWSR) Survey

The river inspection for the month of January took place on 19th and 23rd.

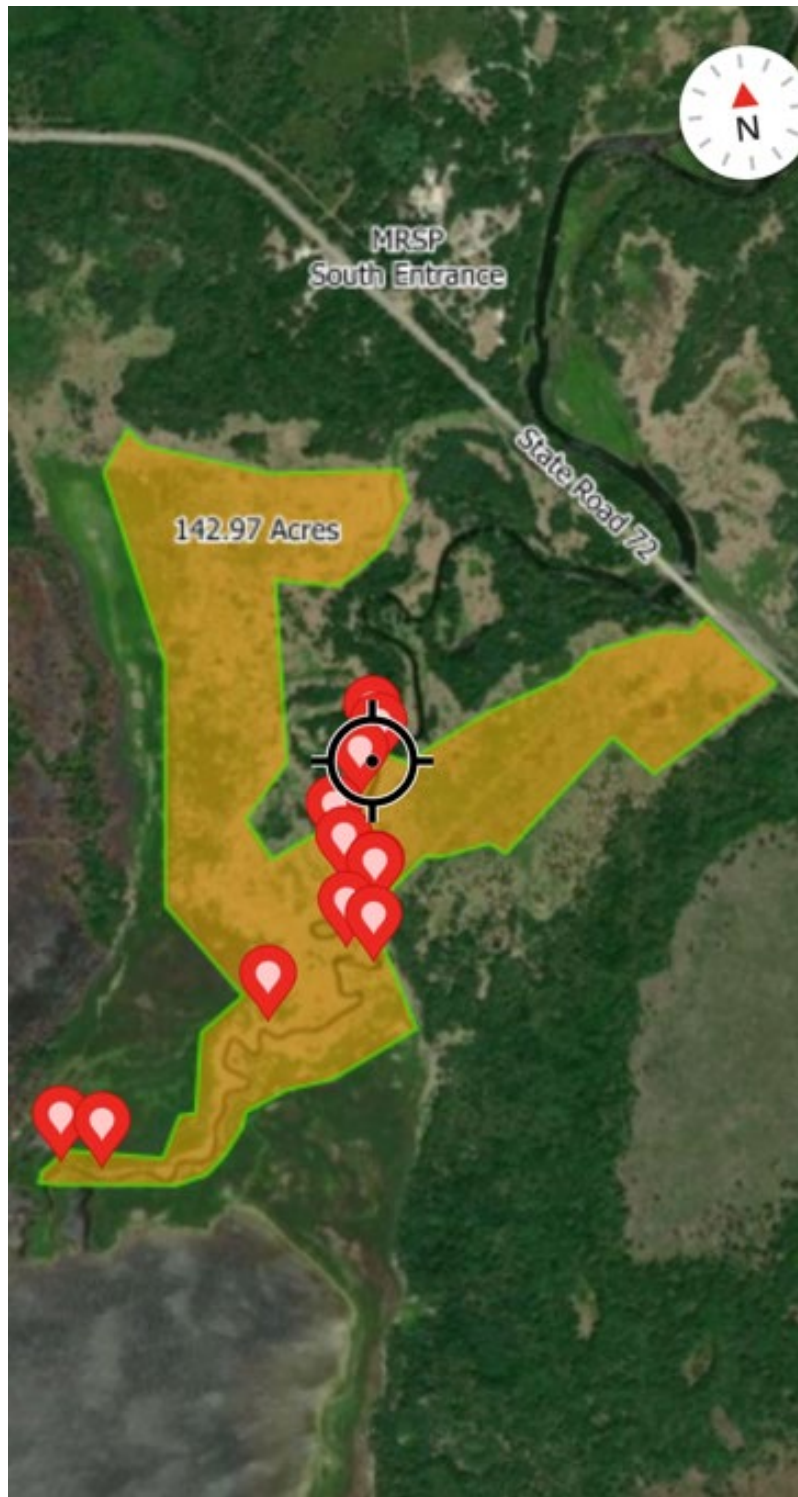
Invasive grass reduction target area in orange with red photo-points along the river taken where burn was apparent.

Additional Notes: As discussed in prior reports the FPS staff has coordinated work efforts with FWC to improve the floodplain marsh within MRSP by reducing non-native grasses. In early October the first major effort against non-native grass in the floodplain south of S.R. 72 occurred with an aerial herbicide treatment of some of the worst non-native grass monoculture areas. The dense paragrass within the treatment area had browned by the November Survey and on December 7th staff from MRSP conducted a prescribed fire treatment of the lower section of this area treated by helicopter in October.

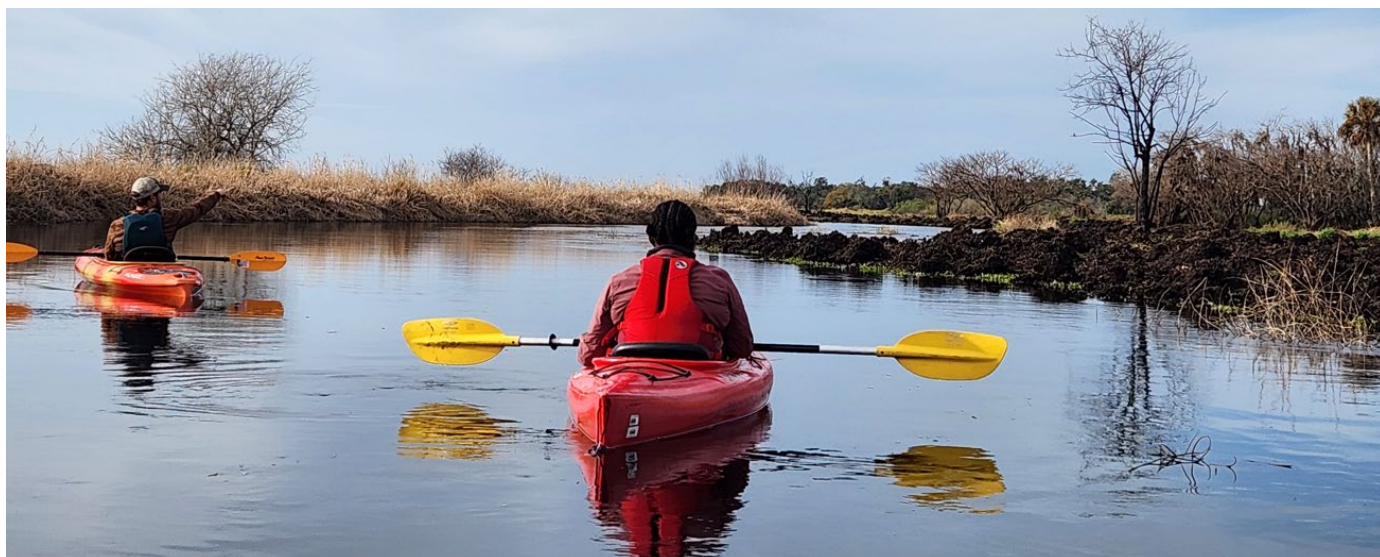
Ben and Zahir scan the December burn area which was completely covered with tall non-native paragrass before the restoration efforts started in October 2023.

In the sections that were burned nearly all paragrass material above ground was removed by the fire. With the wall of paragrass removed, it is now quite easy to view the Lower Myakka Lake well in advance of arriving at the river outlet to the lake. With the January rains this treated and burned area is now seeing an emergence of new seedlings. Most of them appear to be native broadleaf species. Numerous species of birds were seen foraging in this area previously of little value. One American kestrel, several tri-colored herons and limpkins were seen hunting there. Fourteen kill deer were also noted on the now open mud-flat that was formerly occupied by thick grass.

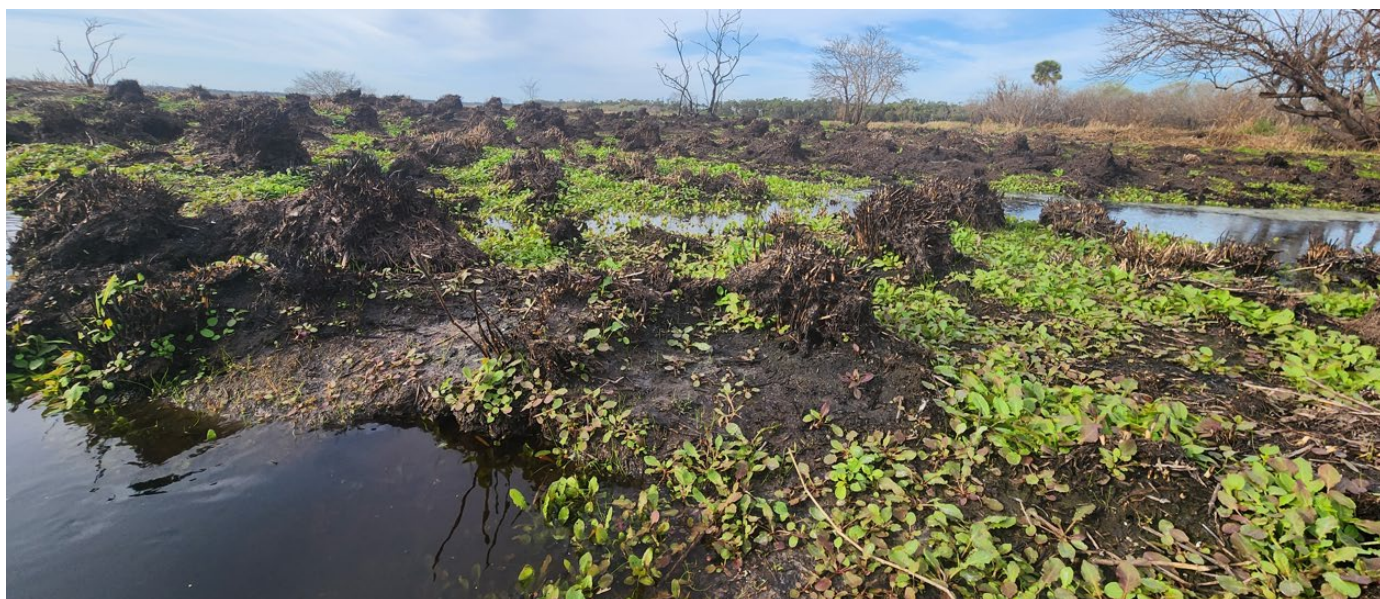
Another example of treated paragrass area which was later burned, now broadleaf species seedlings are emerging from the seed bank.

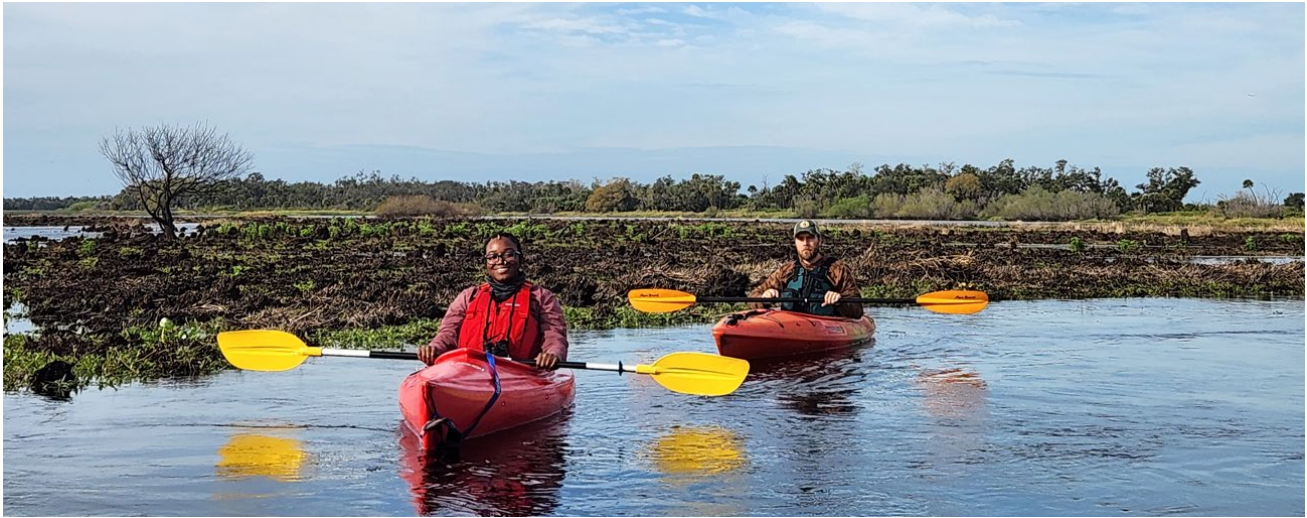
Zahir and Ben paddle along the recently burn marsh with low native vegetation including patches of *Hibiscus grandiflorus* returning.

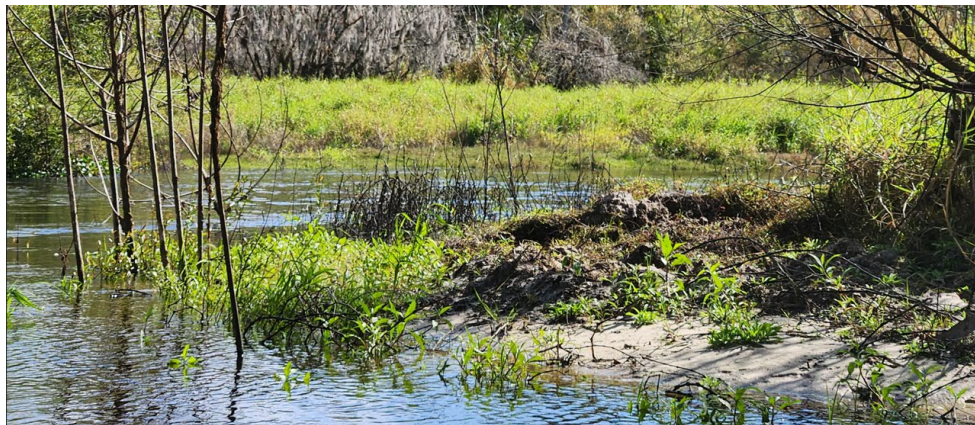
A few sandbars had evidence of feral hog damage. At this one, hogs impacted state-endangered lowland loosestrife.

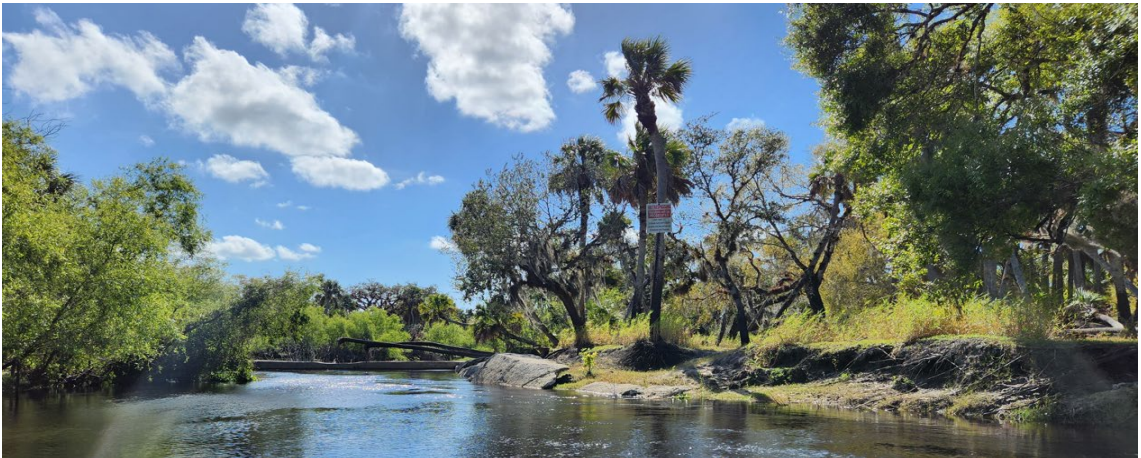
Current view of the approach to Downs' Dam.

Downs' Dam remains a navigation hazard at many water levels. We passed Downs' Dam through the eastern washout area with no difficulty at this water level.

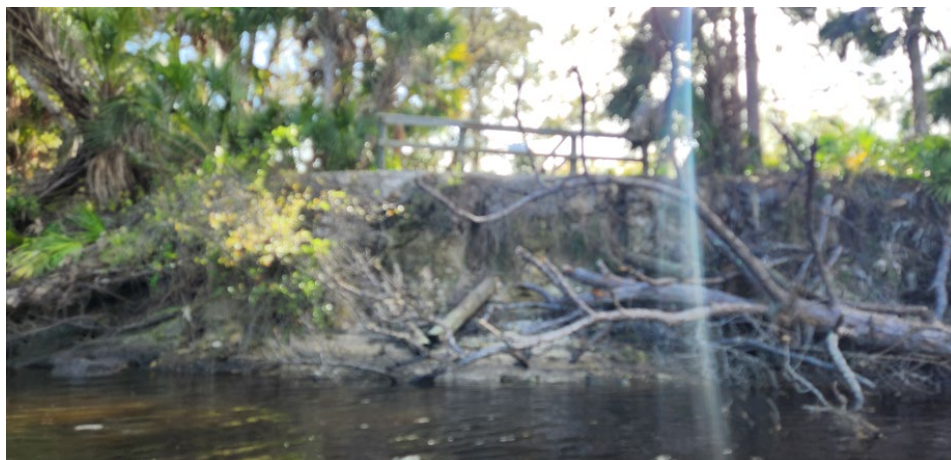
Activities near the southern overlook at the Venetian Golf and River Club may have caused additional bank failure since the last inspection.

Since the last survey, erosion at the southern overlook at the Venetian Golf and River Club increased and activities related to the wooden platform may have caused bank failure since the last inspection.

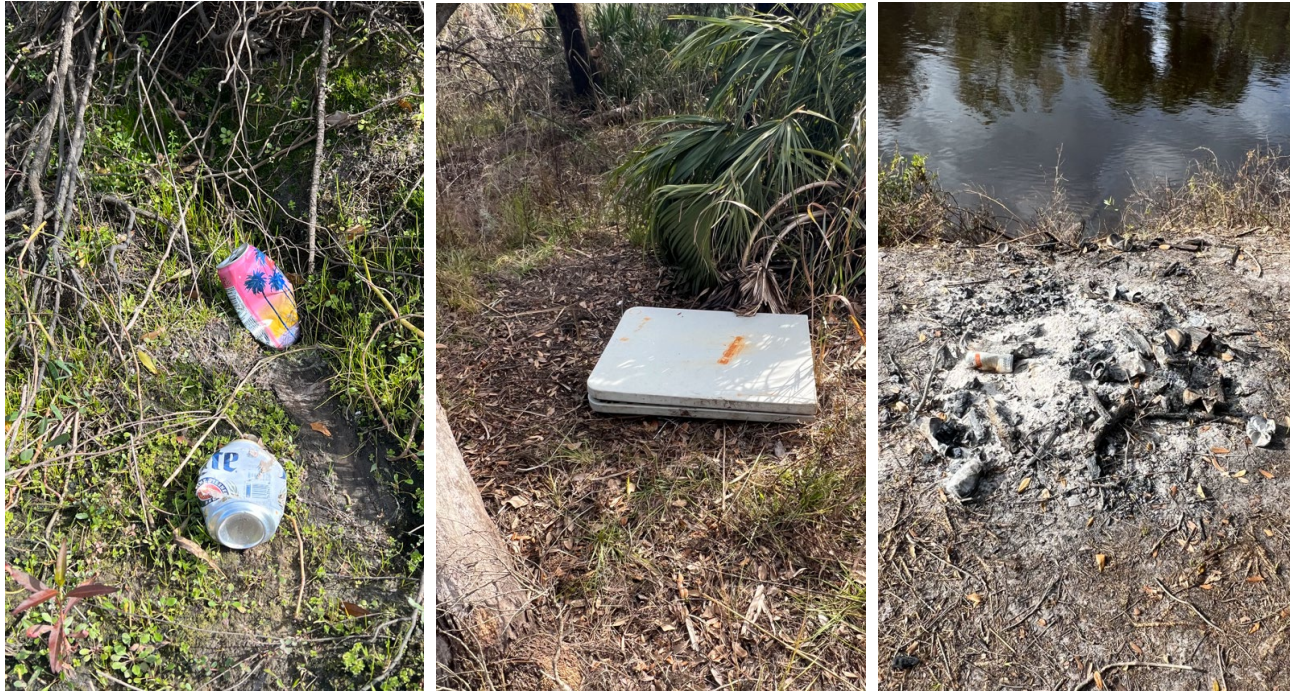
Trash (left) at the foot of the bank, folding table left behind for future use, and trash left behind in recent fire.

As usual minor evidence of unpermitted camping appeared south of MRSP. One site on the Carlton Reserve just south of the Venetian Overlook Area clearly had been used since the last survey. We queued into the site after seeing minor erosion of the bank, some trash and then the fire-pit area.

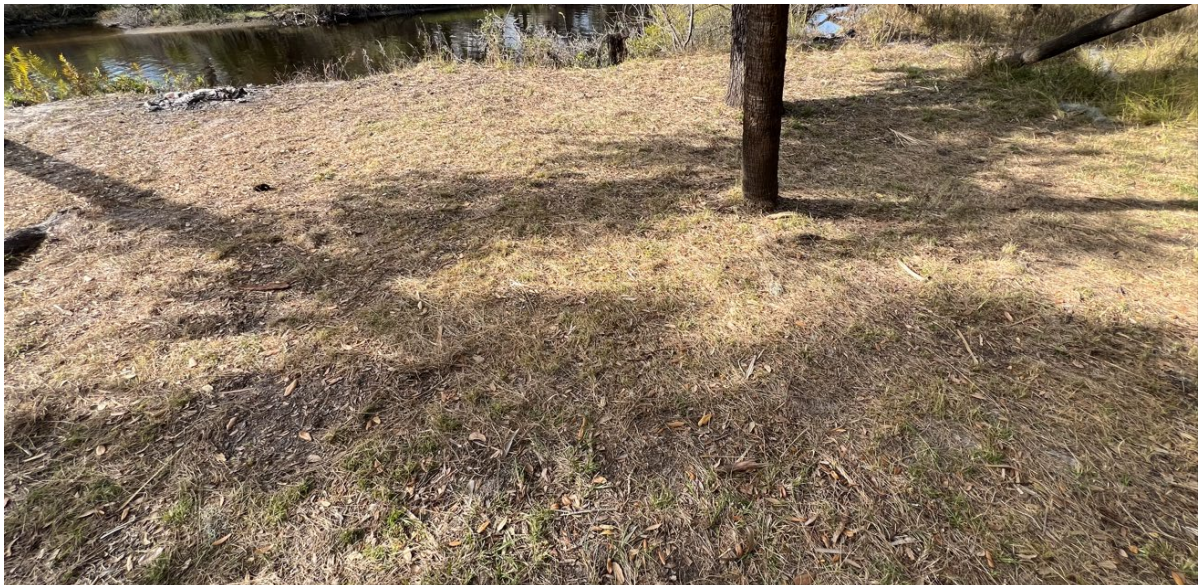
Remnant fire-pit (upper left, same as in above photo) and note large, cleared area for tents right off the river on the Carlton Reserve south of the Venetian Overlook. This site has been used many times in the past.

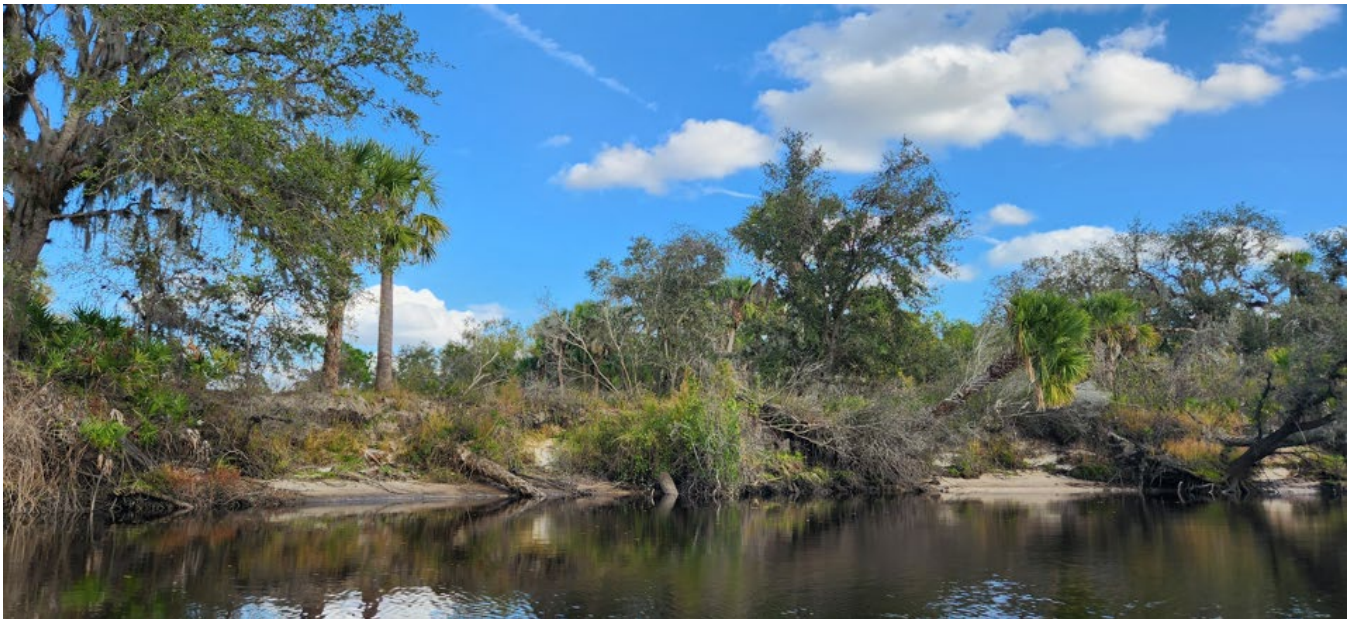
Example of shoreline project across from the VMRP where bank was intended (and permitted) to be stabilized with natural materials and plantings which never fully established.

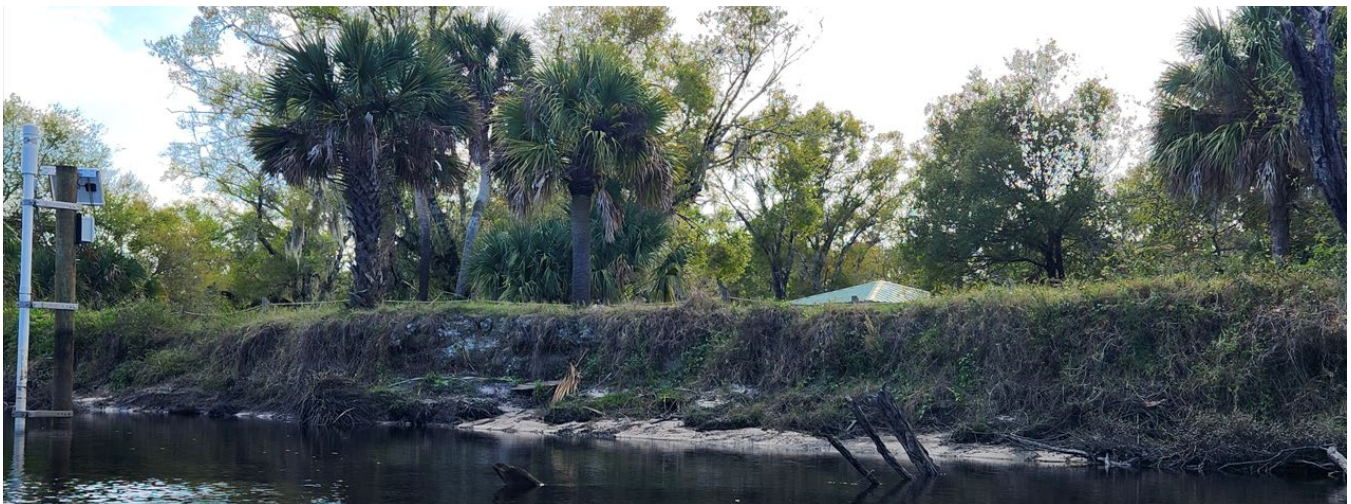
This area along VMRP where the bank has experienced some annual erosion. This bank is near a multi-use recreational trail. Some discussions have occurred about moving the trail and/or attempting to stabilize the bank with natural materials and plantings.

Additional notes: Continued signs of minor erosion from egress to the water are present on conservation park lands and on private properties. These impacts are often cumulative. Human movement up and down the bank can reduce or eliminate riverine vegetation which holds the soil in place. During this survey the continued removal of bank vegetation, including trees, was apparent. Any practice that causes disturbance can be the first step toward erosion. Erosion can accelerate, especially when aggravated by natural and human activities.

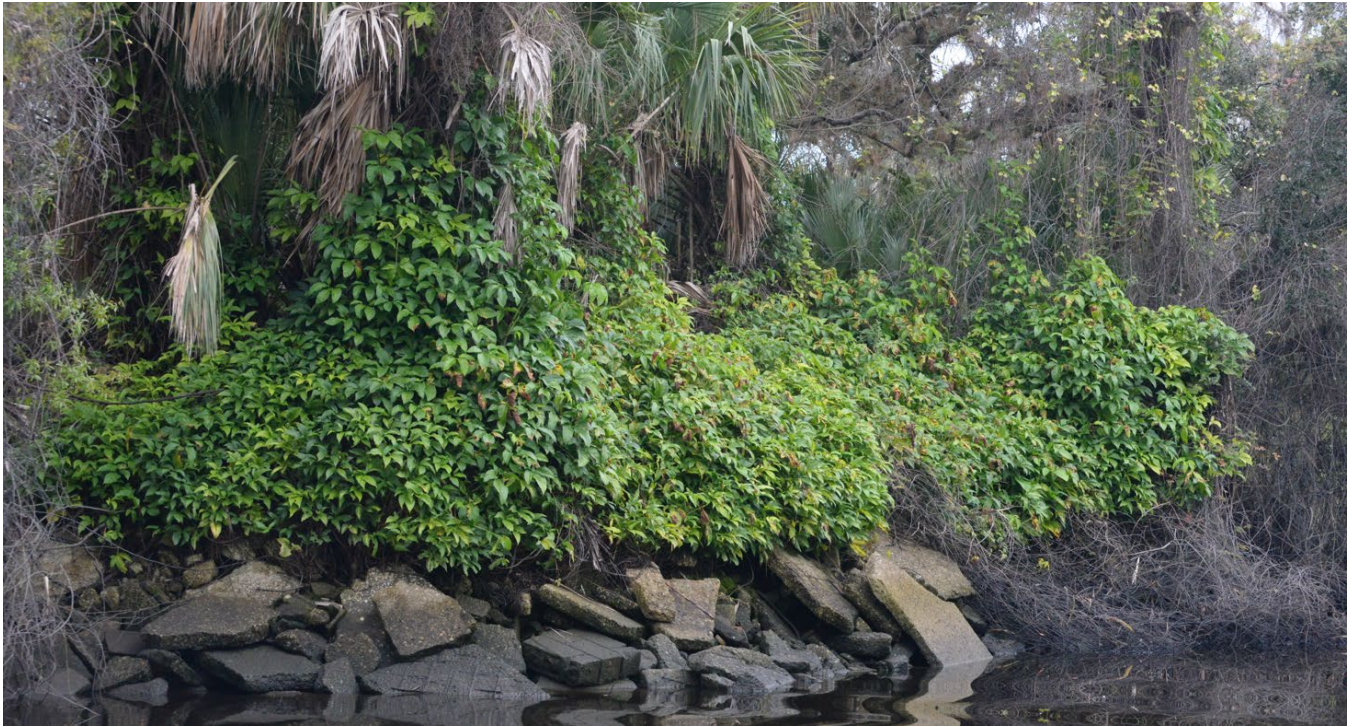
Non-native American evergreen, *Syngonium podophyllum*, covers the bank to the mean-high water level in a section along Sleeping Turtles Preserve.

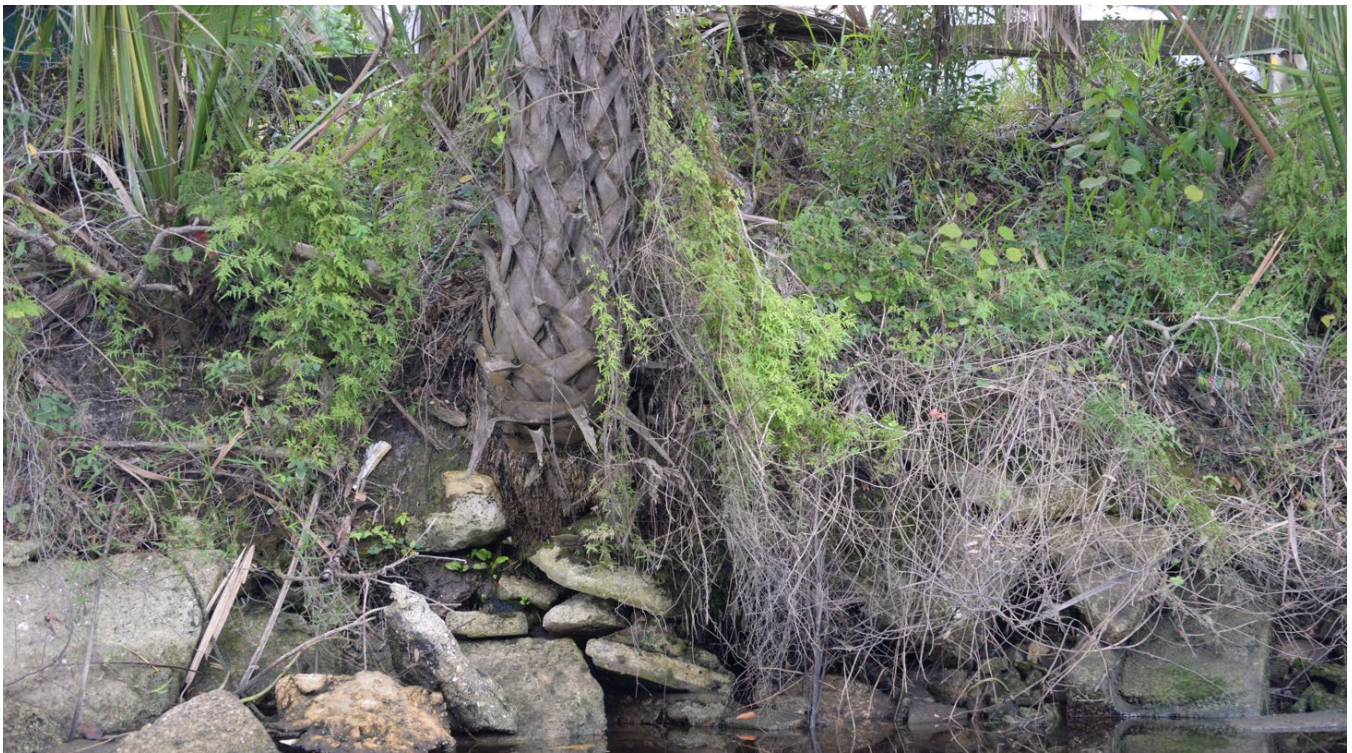
Japanese Climbing Fern, *Lygodium japonicum*, seen here along SHP, is not as commonly found in the river area as non-native “world old” or small-leaf climbing but both species are expanding post Hurricane Ian.

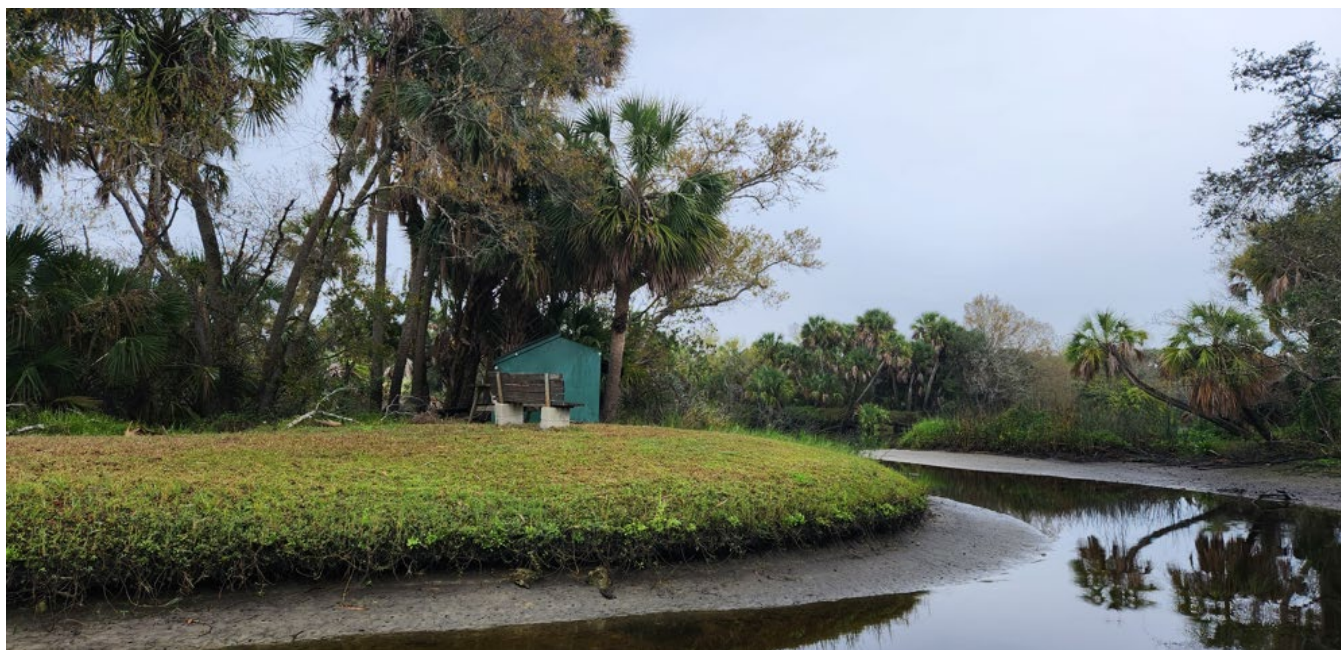
A commercial metal dumpster remains in the river area, from Hurricane Ian, at the inlet to the Venice Camp Retreat.

Debris from Hurricane Ian remains present in the river area and Myakka River Protection Zone from near River Palms down to the Charlotte County line and may have a significant impact on natural resource values. It is important to note, the most impacted area from man-made debris is south of US 41. Some large items like dumpsters, trash cans, and barrels remain along the river. By far the most common remaining item is Styrofoam. In many areas that have received an initial effort to remove Styrofoam debris, but other areas have not been worked. Much of the Styrofoam has degraded and is breaking into small pieces. Also, much of the mangrove canopy is recovering and marsh vegetation is re-growing making this debris less visible. These factors make any future cleanup more difficult.

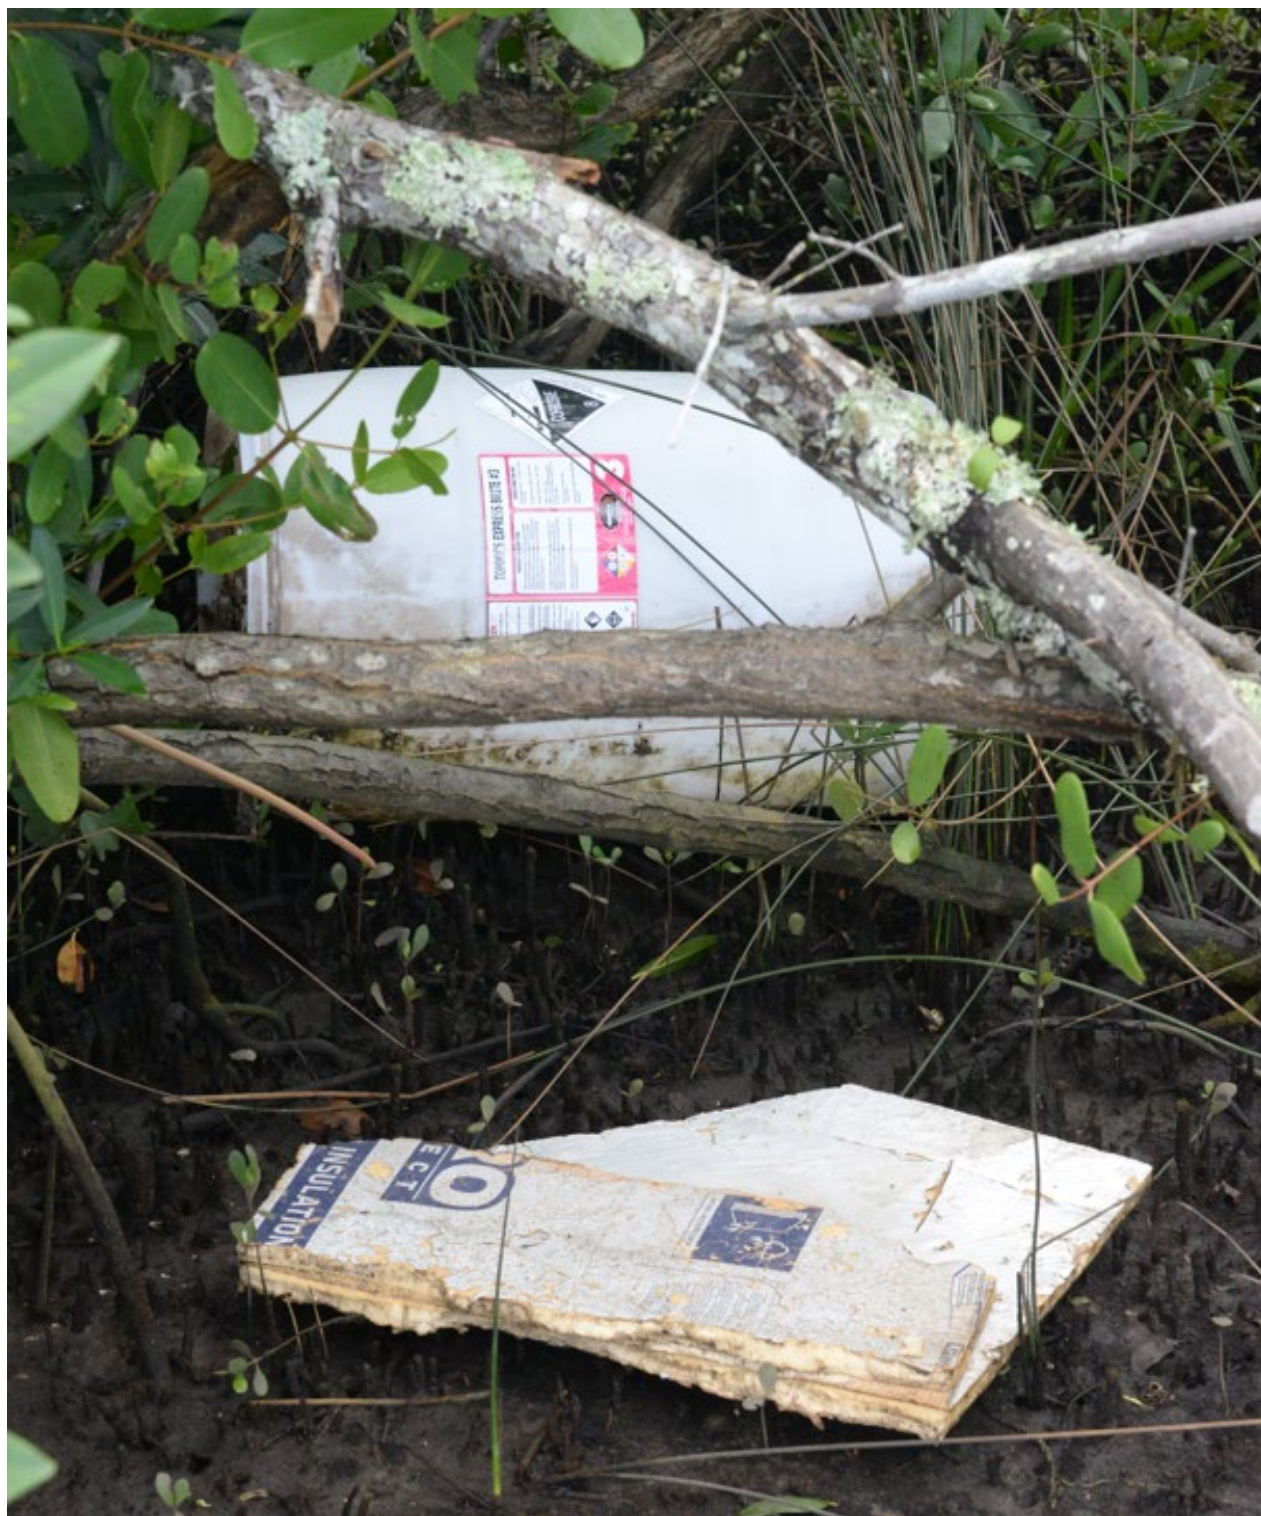
Debris from Hurricane Ian remains especially in the tidal Myakka River. This example shows some Styrofoam insulation next to a large container of “Danger” labelled cleaning agent.
